Railcar Wheels Sub-surface Defect Monitoring Using Ultrasonics

Anish Poudel, PhD

Principal Investigator – NDE

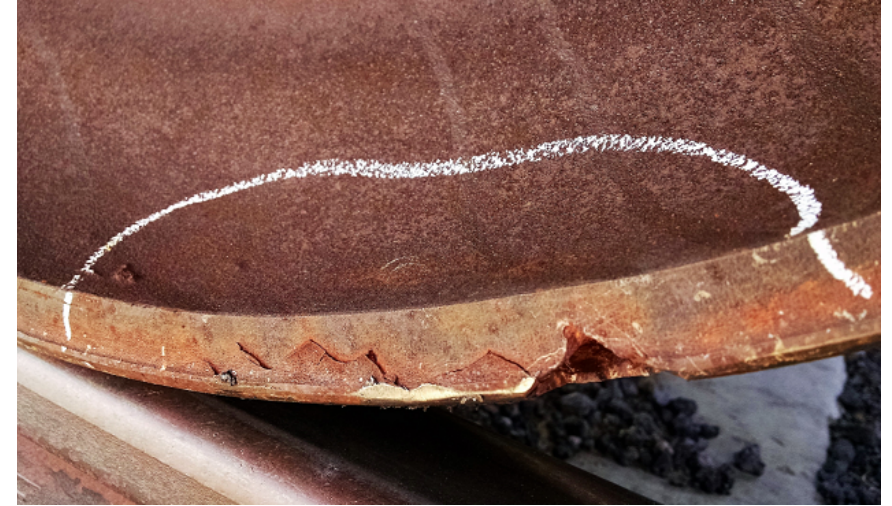
Sub-surface Fatigue Crack Features

- Sketch of a fatigue crack which nucleated about 4 mm below the surface. Maximum depth of the crack below the wheel tread is about 14 mm
 1. No sign of inclusions or voids at the point of initiation
 2. Crack initiates at a depth of 3-10 mm below the wheel tread
 3. Crack propagates in an angle downward to a depth of about 20 mm
 4. Final fracture toward the surface

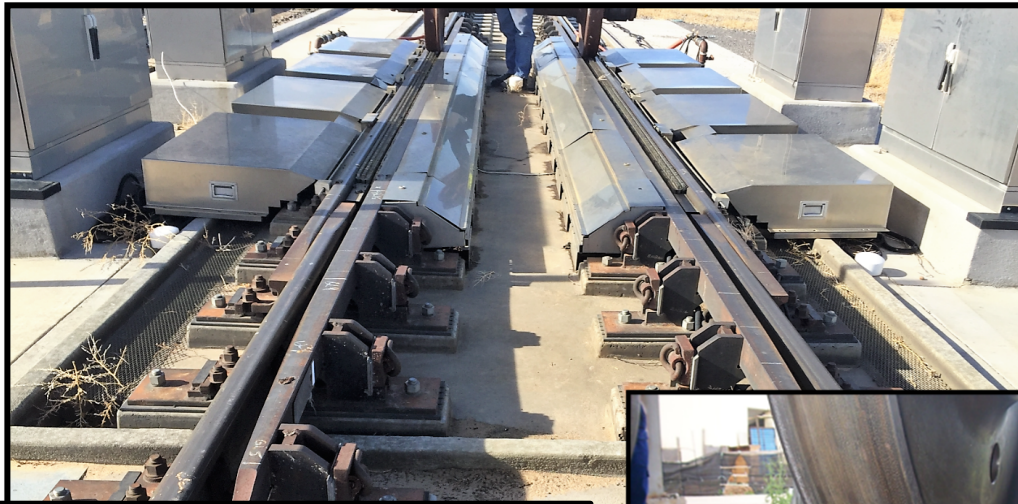
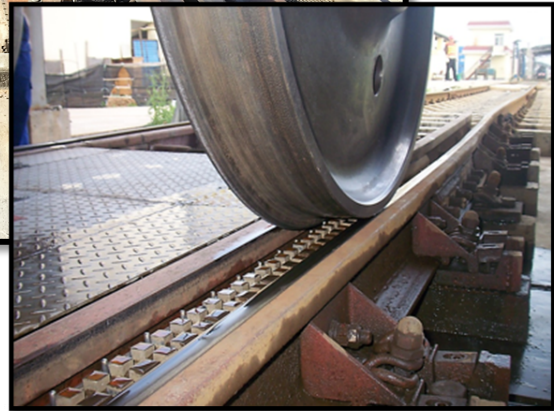
ACWDS

- Technology belongs to Nanjing Tycho company (China)
- Wayside NDE system for inspecting internal cracks on a moving train

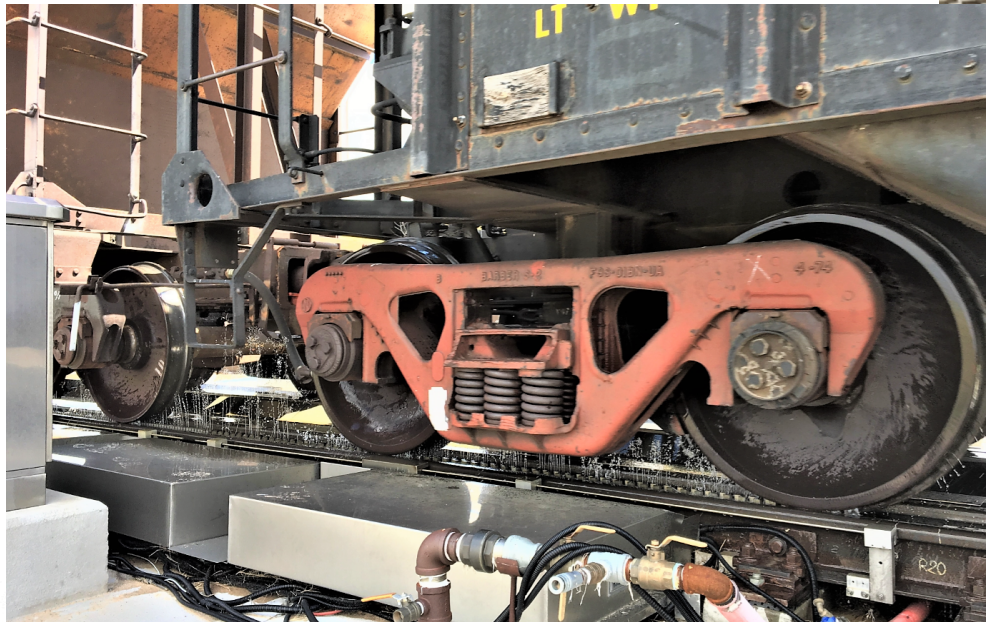
Ultrasonics Hardware Configuration

- Array of Spring-loaded ultrasonic probes
 - 0° UT probes look straight up and detects circumferential cracks
 - 70° UT probes inspect rim face and flange
- Water-based couplant sprayed through nozzles

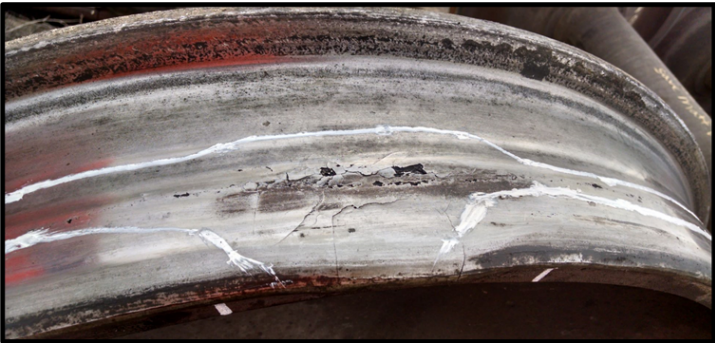
Defect Type	5 mph			10 mph			12 mph			15 mph		
	HITS	MISSES	Detection %	HITS	MISSES	Detection %	HITS	MISSES	Detection %	HITS	MISSES	Detection %
Broken Wheel # 1	15	0	100%	15	0	100%	15	0	100%	15	0	100%
Broken Wheel # 2	2	13	13%	1	14	7%	2	13	13%	1	14	7%
Broken Wheel # 3	15	0	100%	14	1	93%	13	2	87%	11	4	73%
Broken Wheel # 4	15	0	100%	15	0	100%	15	0	100%	15	0	100%
FALSE CALL	0			0			0			1

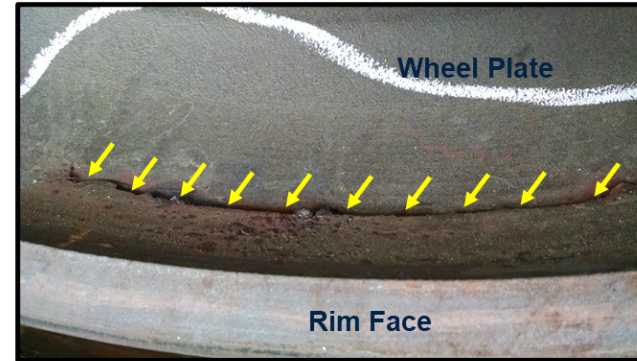
Broken Wheel # 3

- Broken Wheel # 3: Detected 73% at 15 mph

Wheel Cut Open

Flaw shape, size, location, and orientation governs the UT detection!

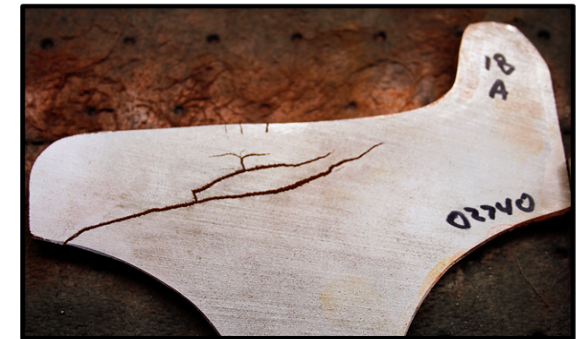
Broken Wheel # 4

- Broken Wheel # 4: Detected 100% at 15 mph

Wheel Cut Open

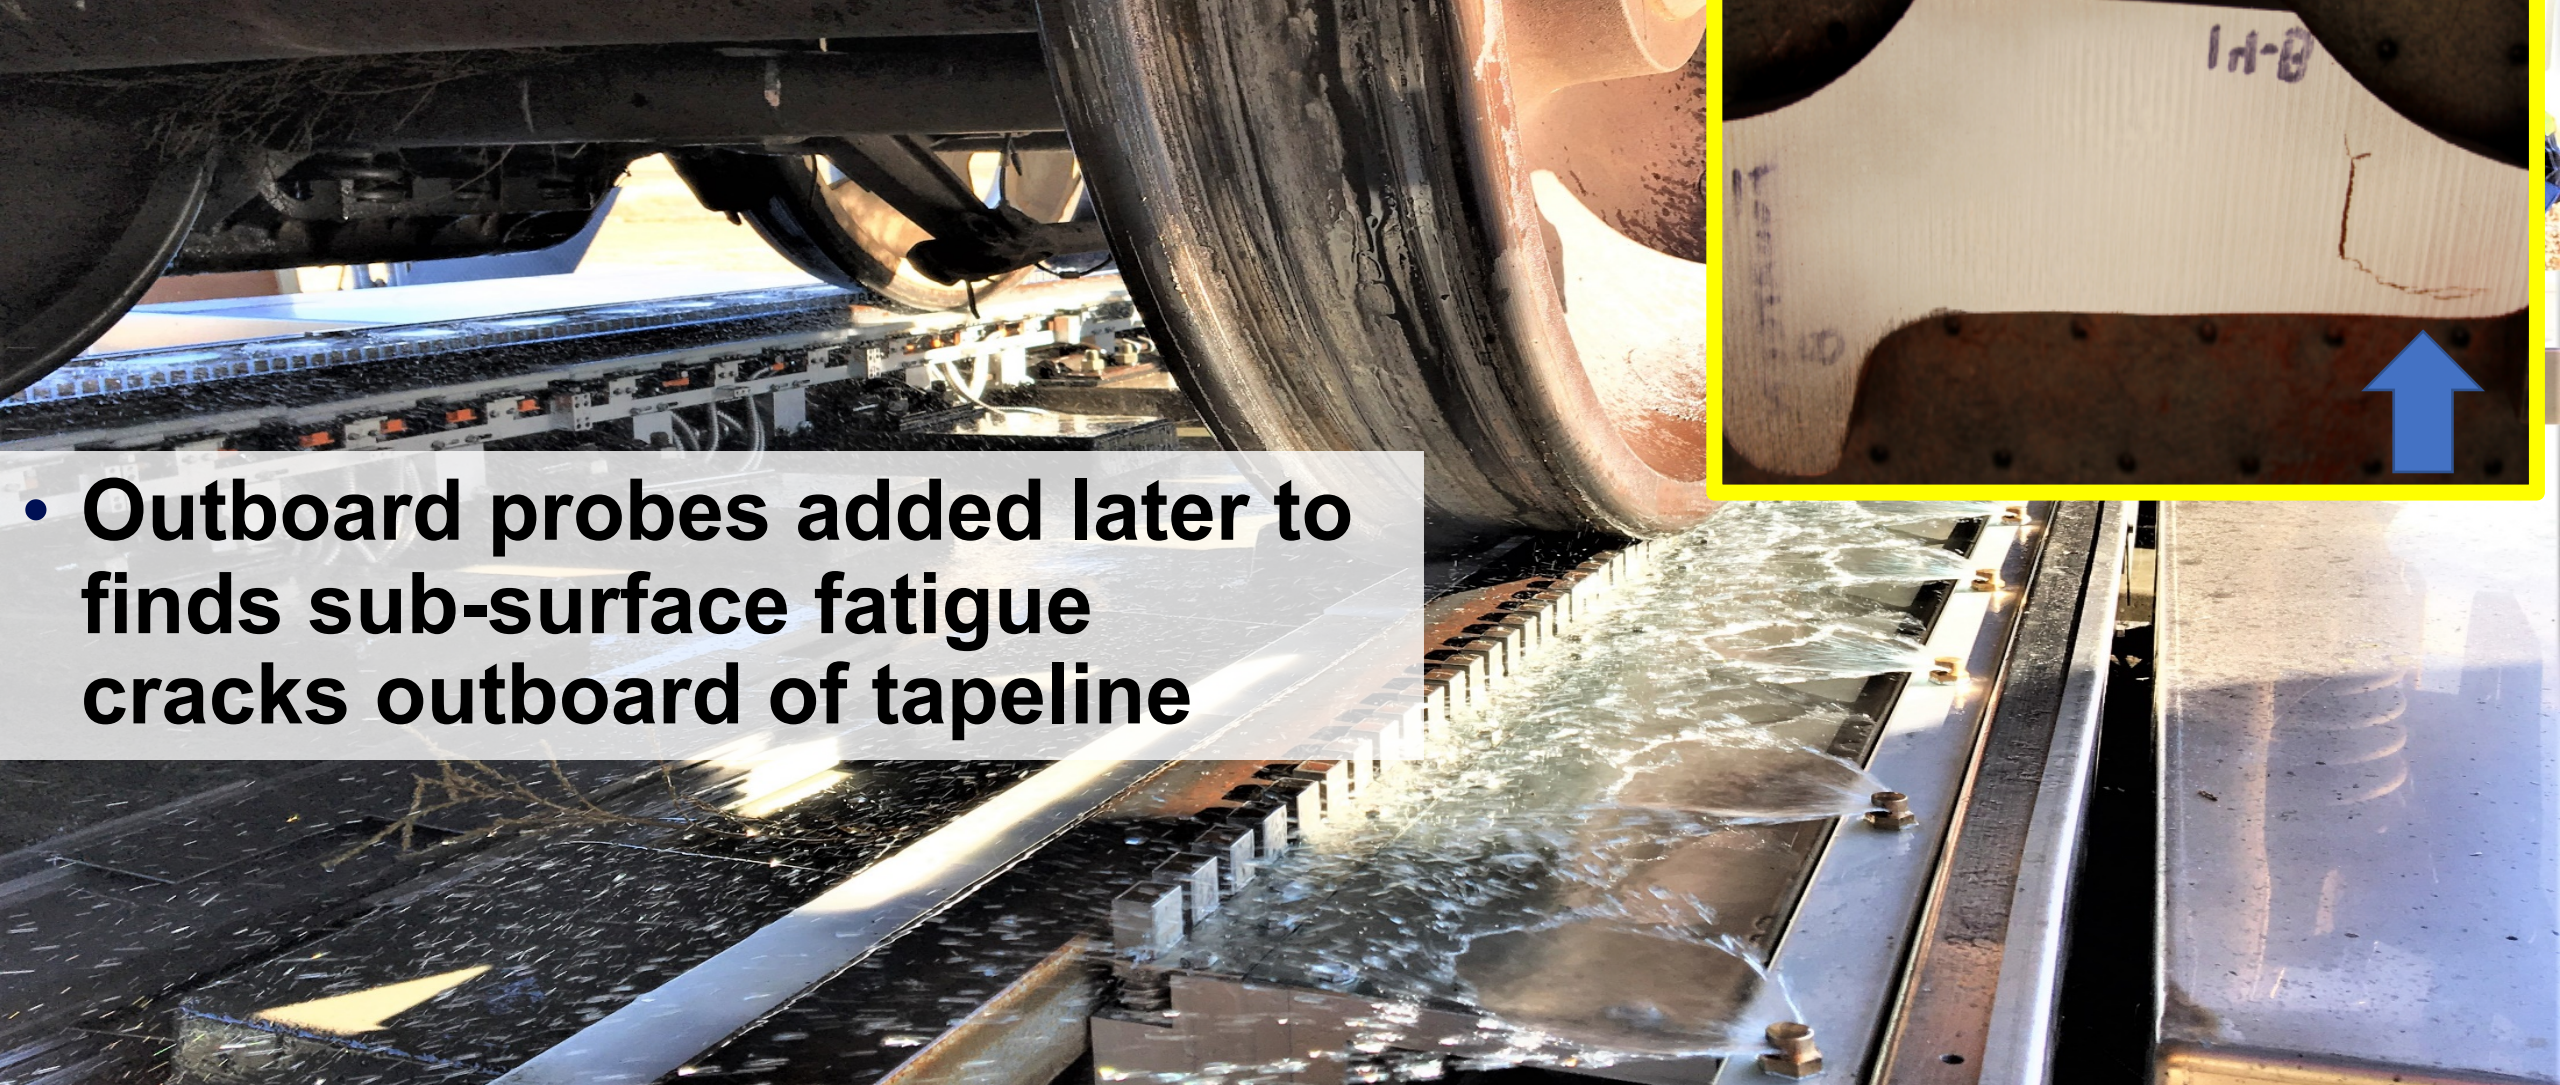
ACWDS Outward Probes

- Outboard probes added later to find sub-surface fatigue cracks outboard of tapeline

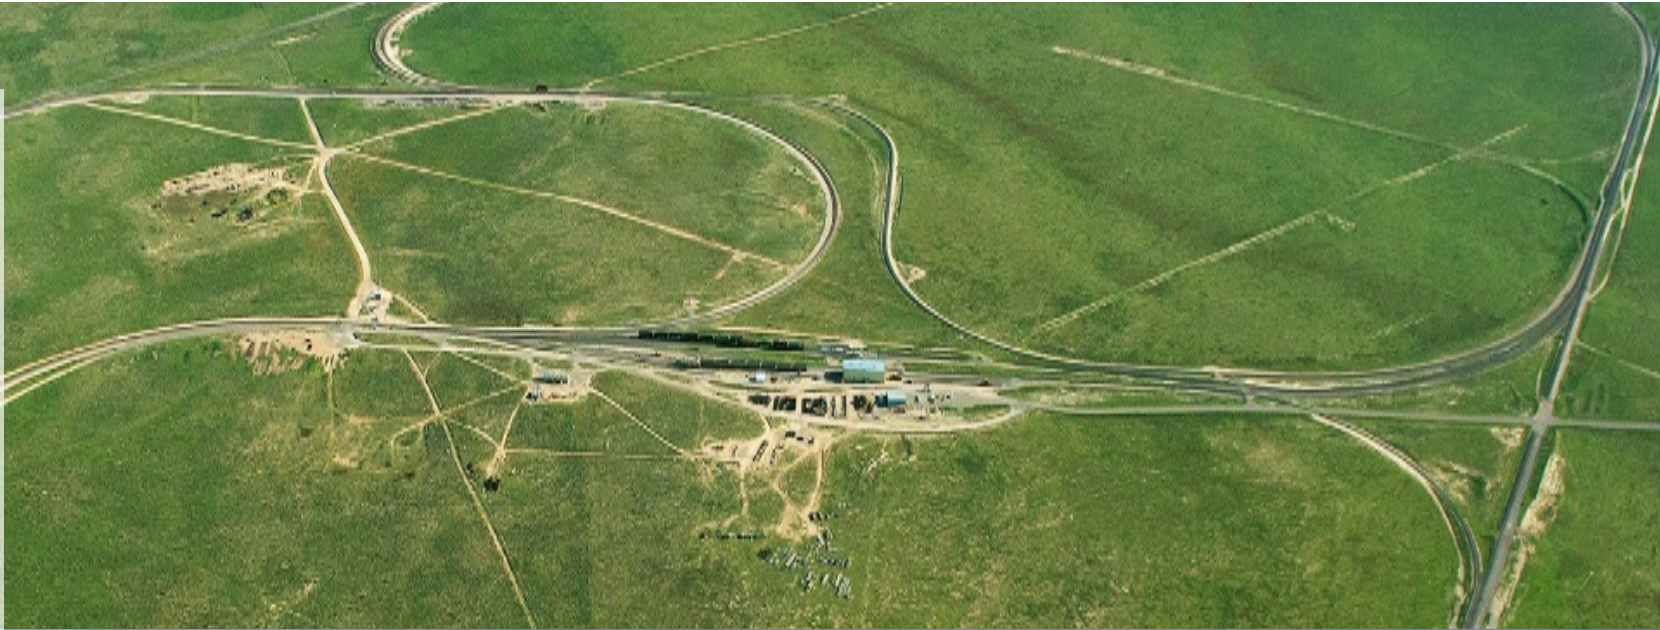
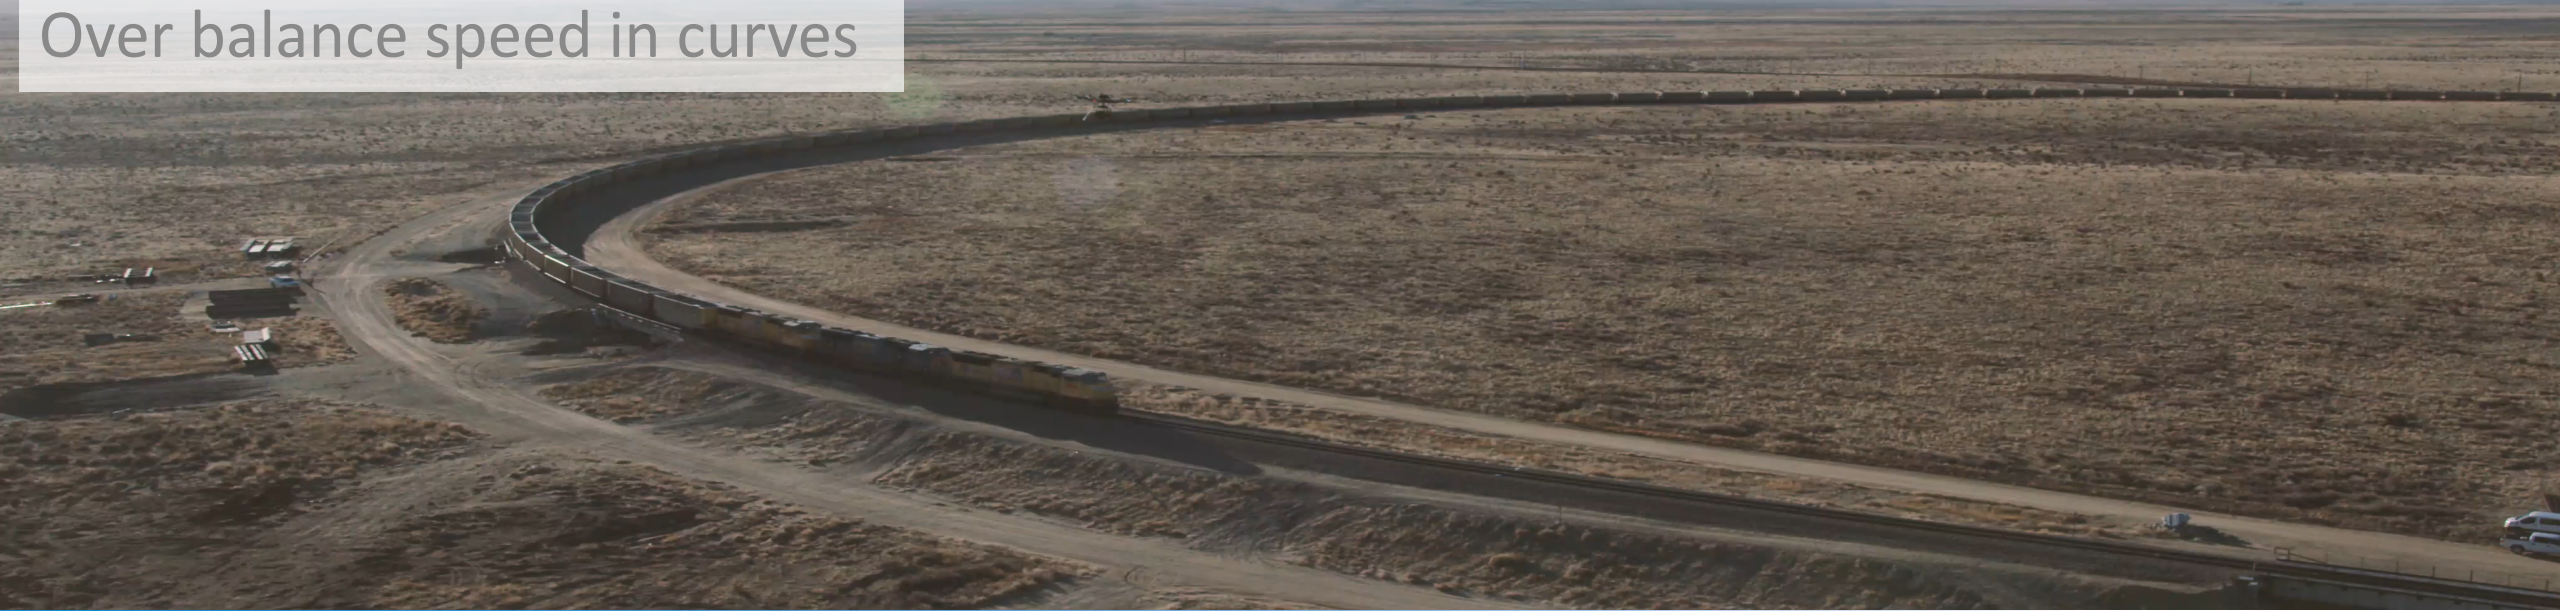
TTCI FAST Operation

High Tonnage Loop (HTL)

2.7 miles

Mostly 315,000-pound cars
(39-ton axle load)

≈50% of train operations
in each direction

Over balance speed in curves

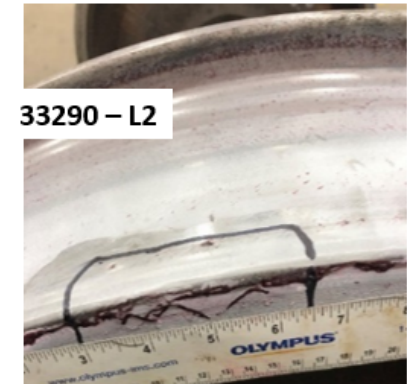
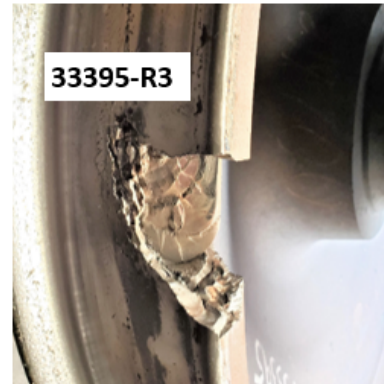
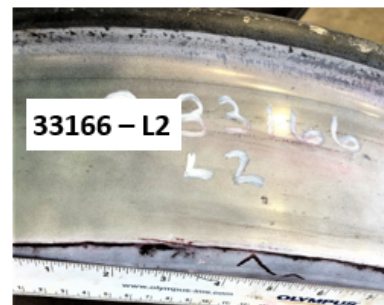
FAST HAL Train – 2020 Broken Wheel Removals

Car position	Car No.	Wheel position alarmed	FAST mileage (miles)	Transducer alarmed	Hand UT verification results
71	33150	R3	201,751	0° outboard	3.2-inch x 1.5-inch x 0.5-inch
62	33395	R3	219,281	0° outboard 0° wide gage	3.25-inch x 2.75-inch
7	33166	L2	138,761	0° outboard	3.4-inch x 1.1-inch x 0.2-0.4-inch
17	33396	R1	194,466	0° outboard	1.0-inch x 1.2-inch x 0.25-inch
88	33317	L2	162,145	0° outboard	7.0-inch x 1.8-inch x 0.3-inch
58	33164	L3	156,027	0° outboard	5.25-inch x 1.5-inch x 0.2-0.7-inch
72	33290	L2	56,829	0° outboard	3.5-inch x 0.9-inch x 0.3-inch

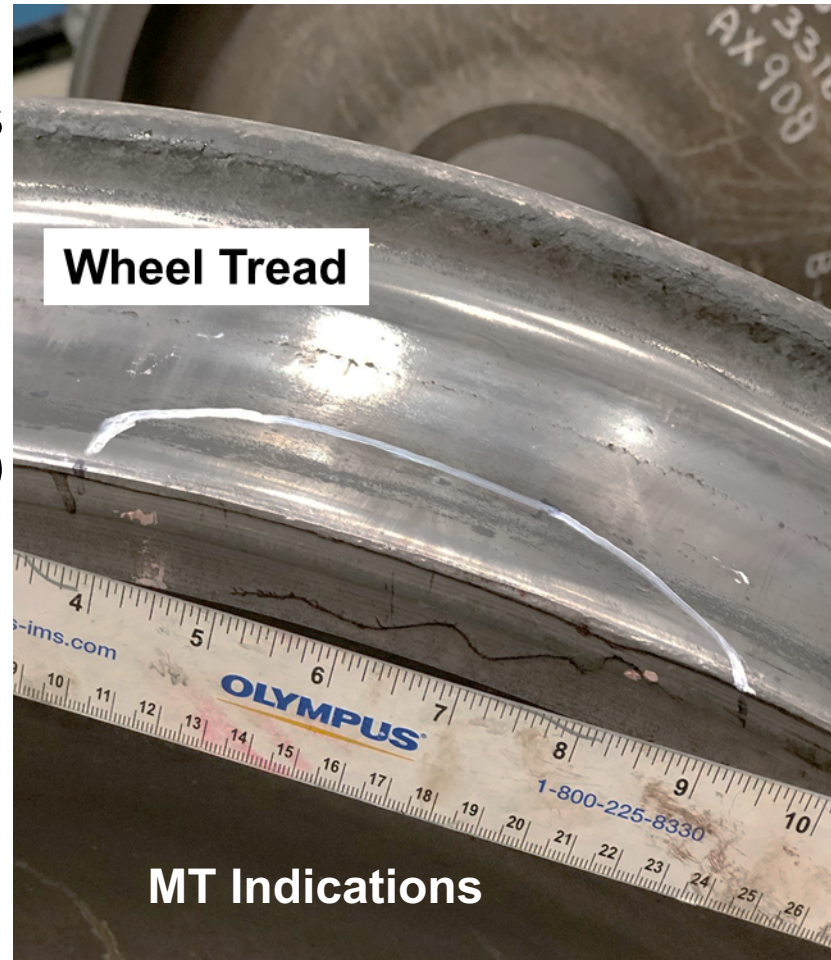
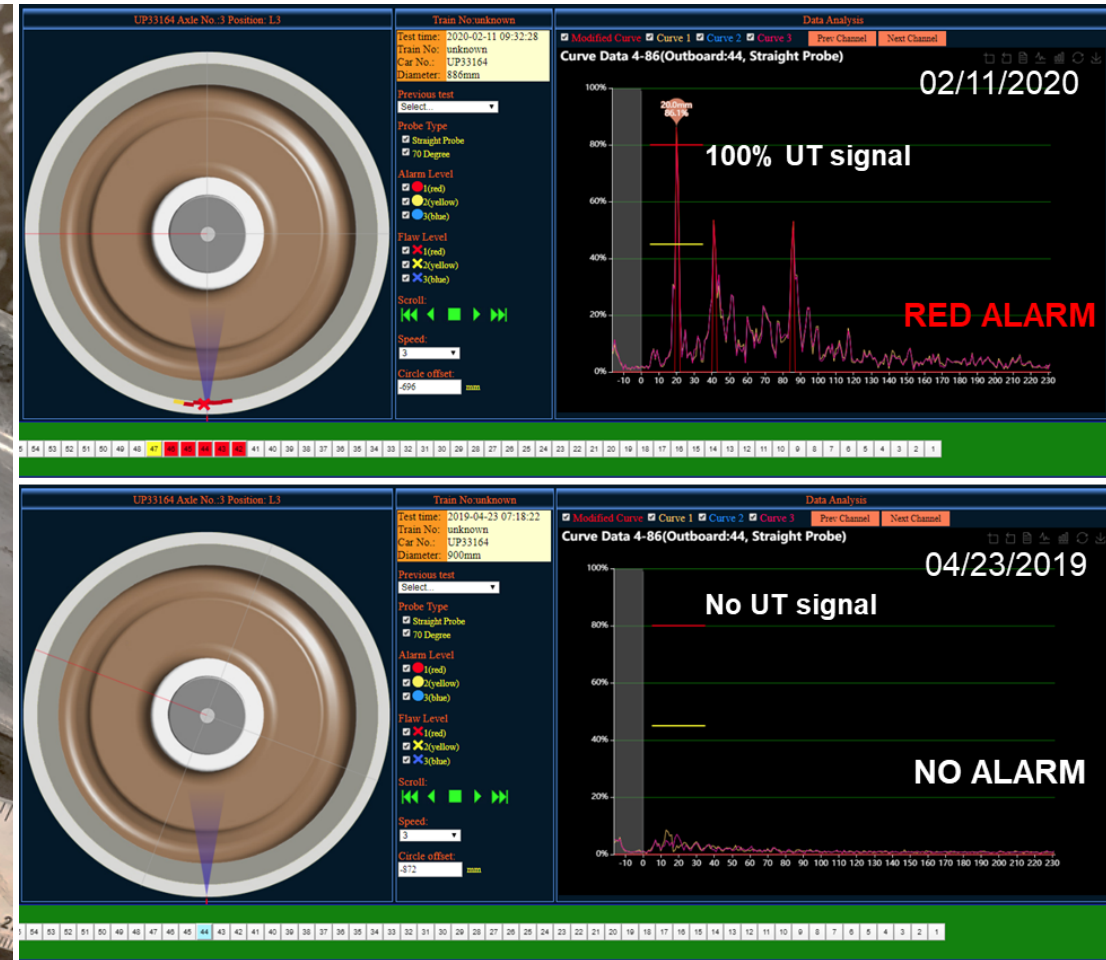
FAST Car 33164 Wheel L3

- Detected by 0° outboard probes
- Hand-UT Verification
 - 5.25-inch (L) x 1.5-inch (W) x 0.2-0.7-inch (D)

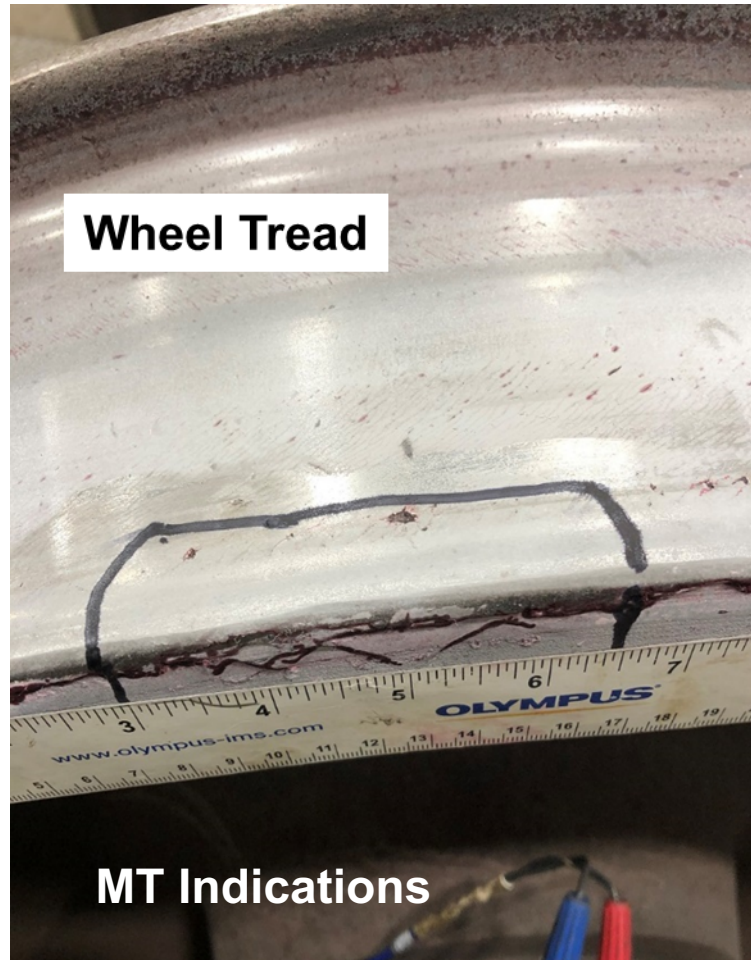
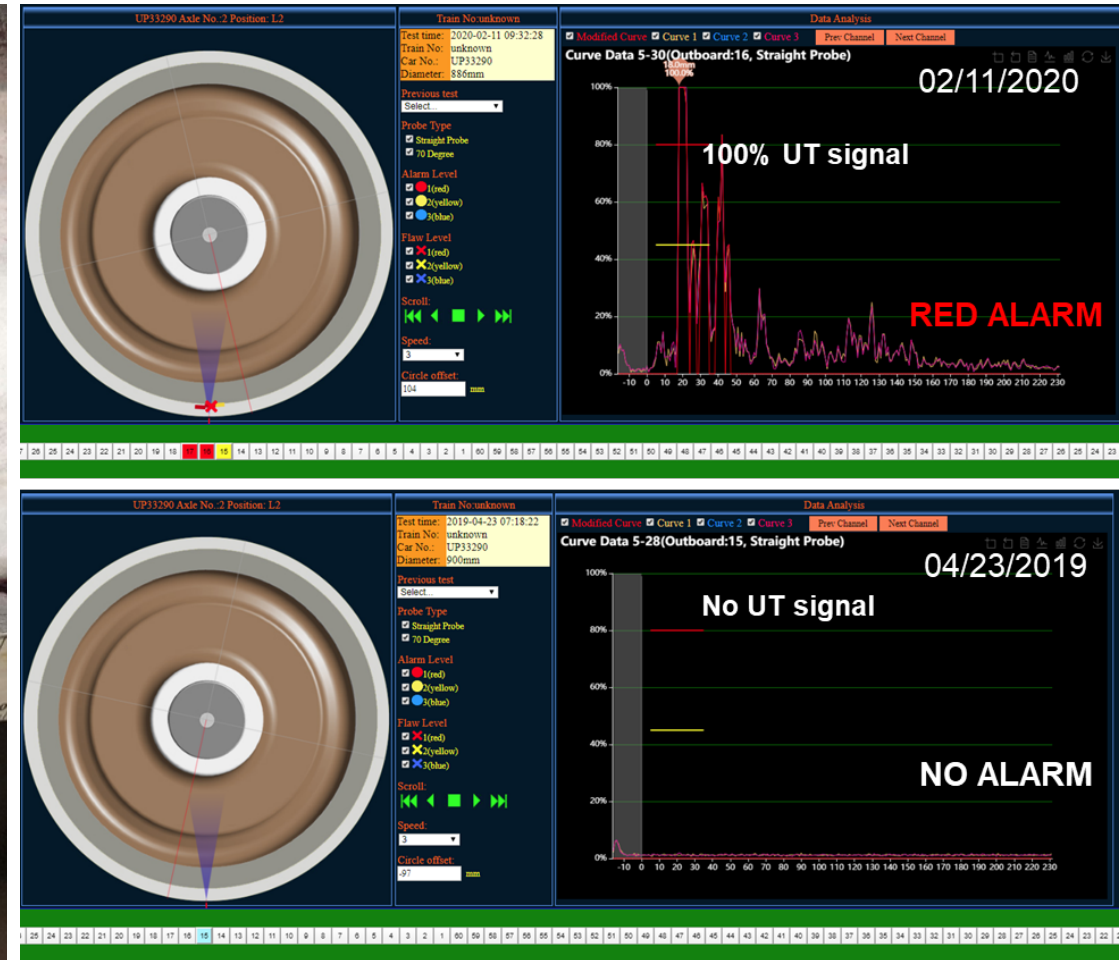
FAST Car 33290 Wheel L2

- Detected by 0° outboard probes
- Hand-UT Verification
 - 3.5-inch (L) x 0.9-inch (W) x 0.3-inch (D)

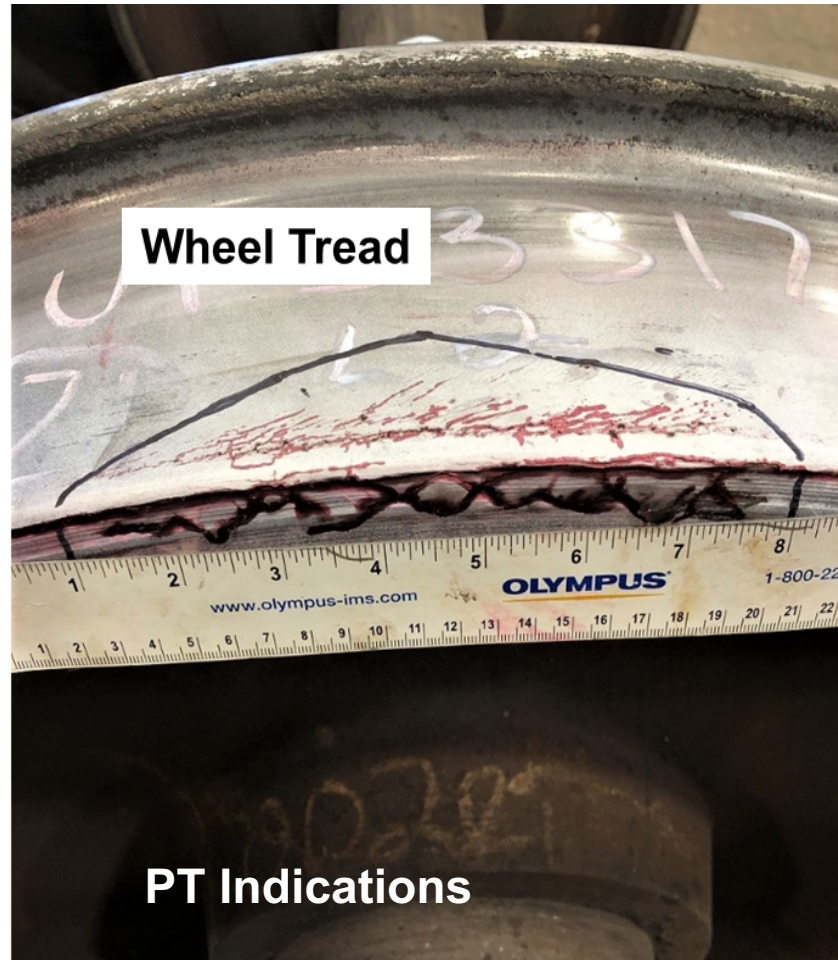
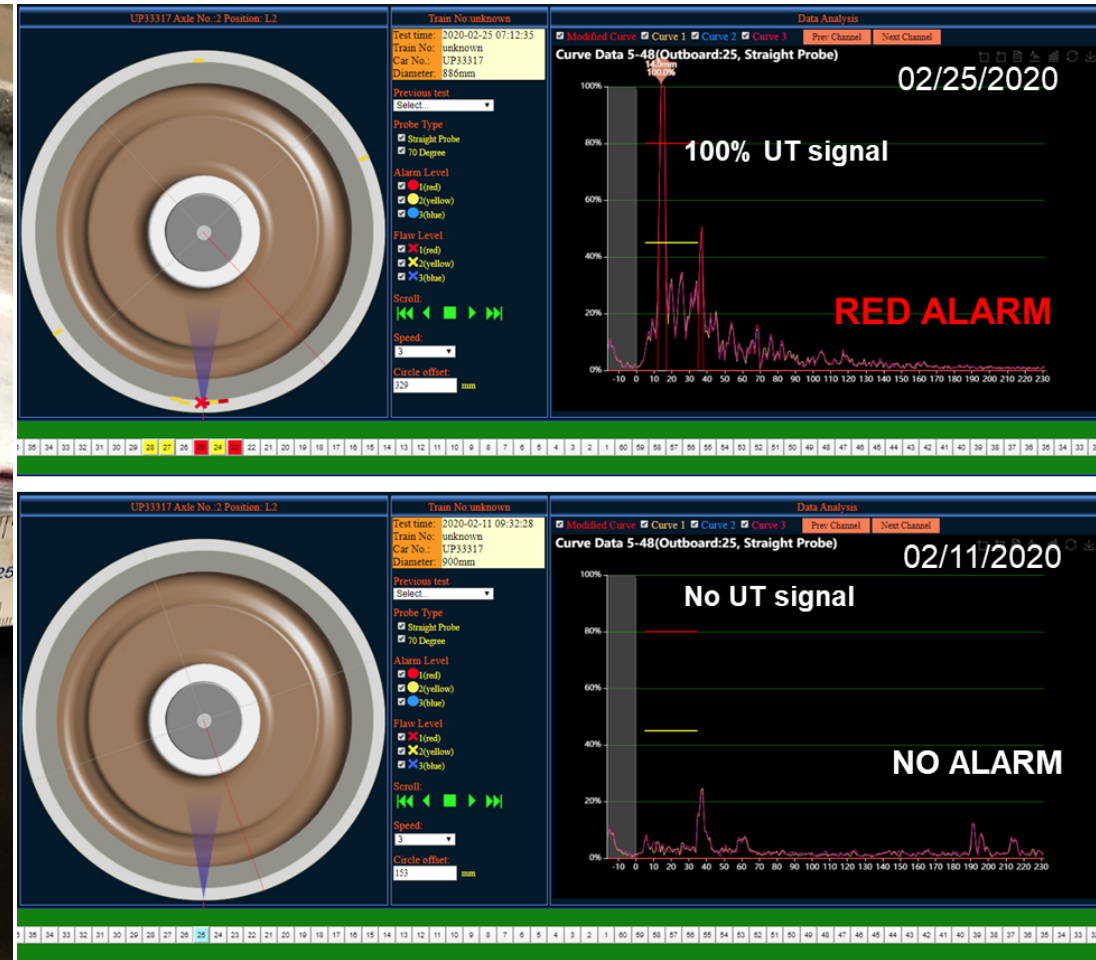
FAST Car 33317 Wheel L2

- Detected by 0° outboard probes
- Hand-UT Verification
 - 7.0-inch (L) x 1.8-inch (W) x 0.3-inch (D)

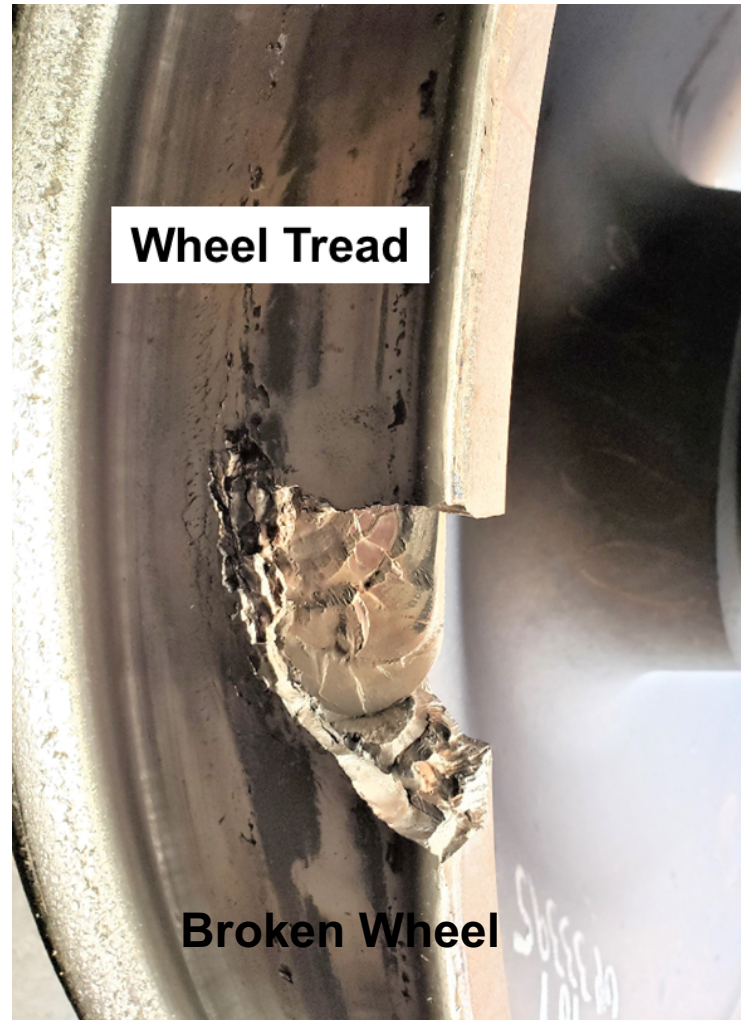
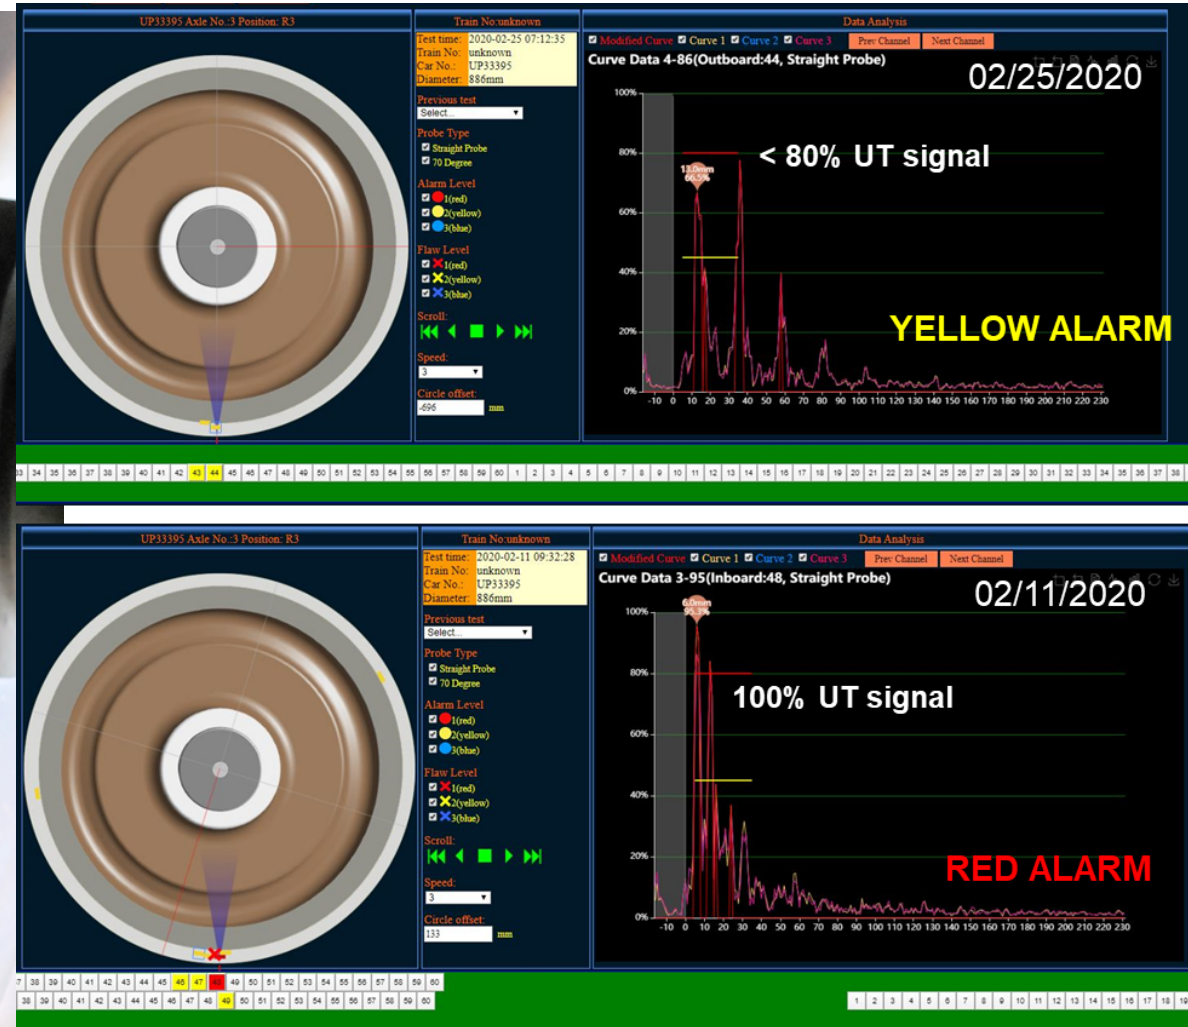
FAST Car 33395 Wheel R3

- Detected by 0° inboard/outboard probes
- Hand-UT Verification
 - 3.25-inch (L) x 2.75-inch (W)

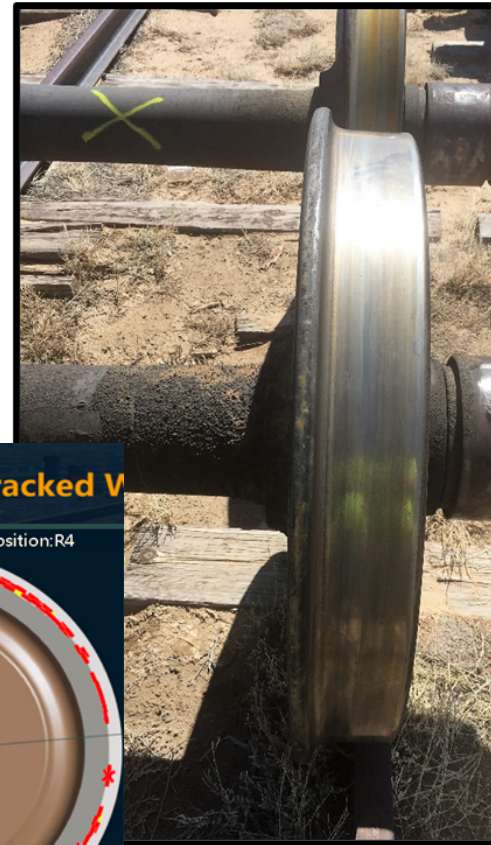
INCREASING SEVERITY

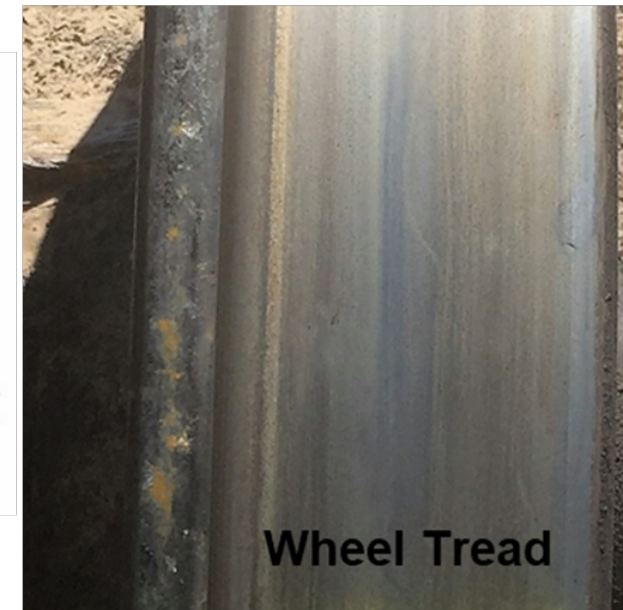
FAST Car 33376 Wheel R4

- Hand UT NDE findings:
 - Sub-surface fatigue cracks
 - Length: entire circumference
 - Width: 1.4-inch to 1.5-inch
 - Depth: 0.24-inch to 0.36-inch
 - Location: 1.7-inch from the rim face

Hand-UT Flaw Mapping

Wheel Tread

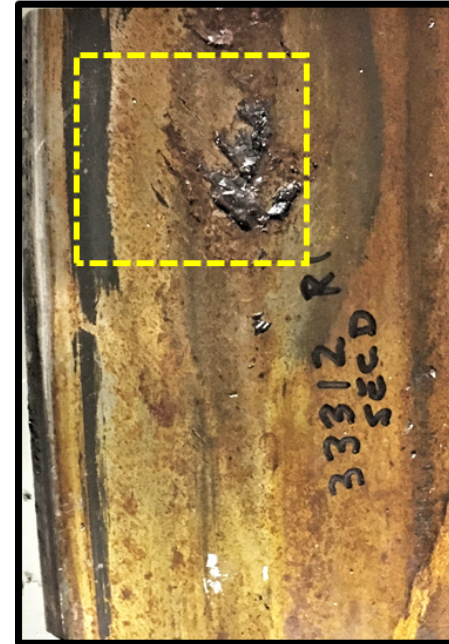
FAST Car 33312 Wheel R1

- Class C wheel manufactured in November 2004
- Total of 166,131 miles and 23.76 MGTM at FAST from 09/2009 to 05/2016
- RCF/spalling observed at two locations next to one another in the wheel tread
- Spall length and width was 1.2-inch (30 mm) by 0.8-inch (20 mm), respectively
