# Managing Challenging Leaking Petroleum Storage Tank Sites with Case Studies

Presented by Emily Chen, P.E. and Ben McIvor, P.G.  
Texas Commission on Environmental Quality  
Office of Waste | Remediation Division | PST/DCRP Section

June 3, 2025

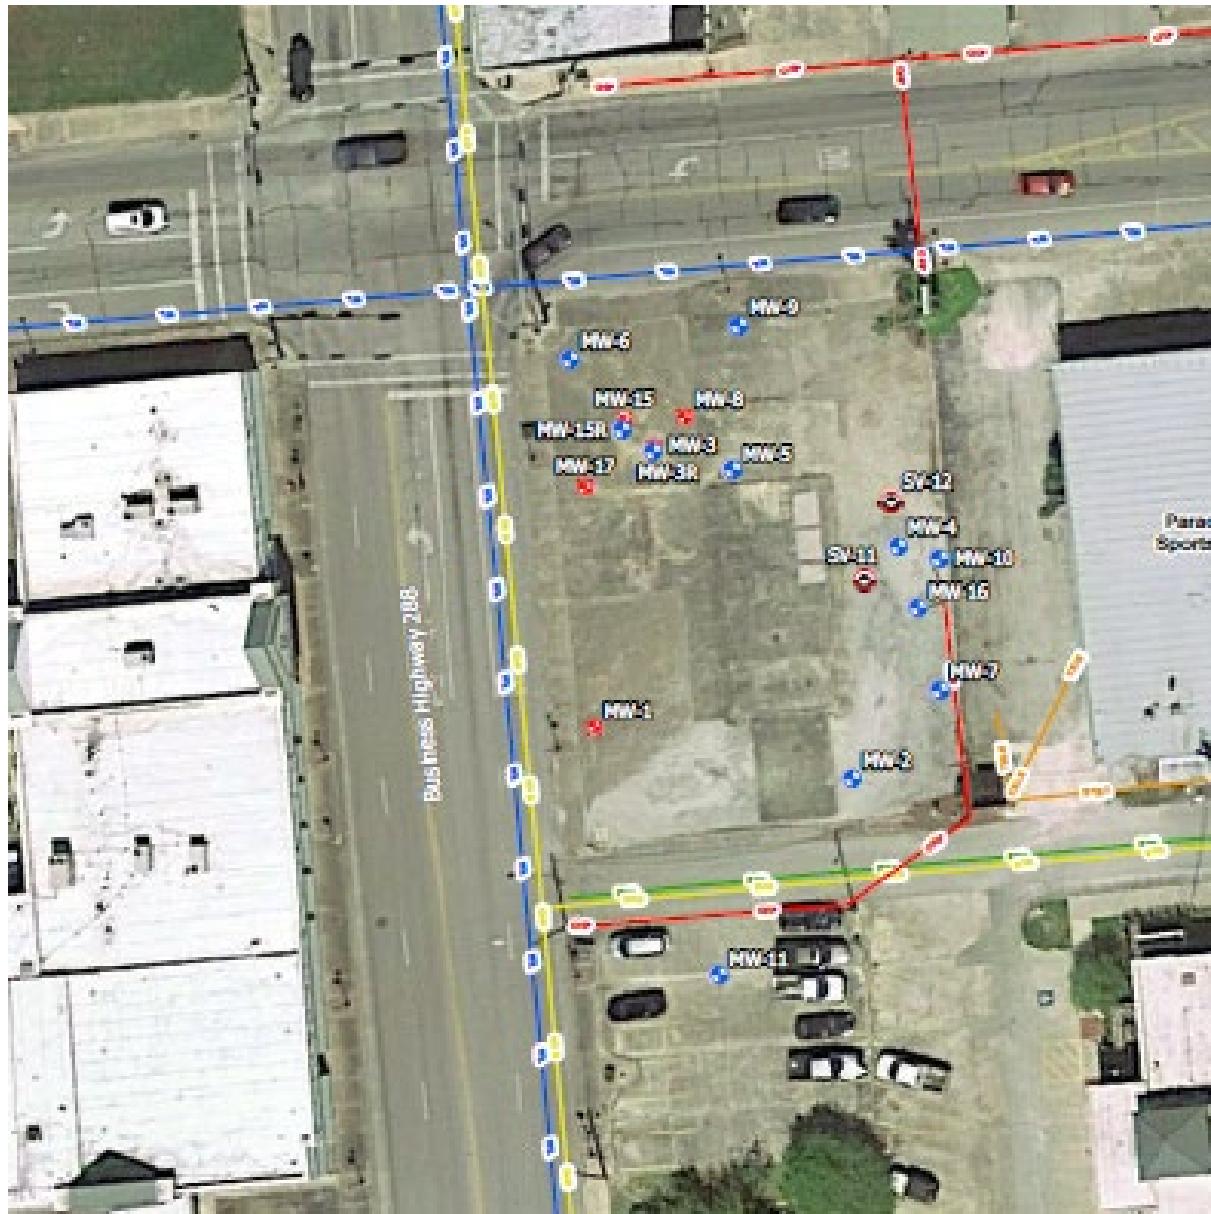
Angleton, Texas

# Case Study 4 Background

## Former UST facility

- Excavation
  - 1,890 square feet; 336 cubic yards
  - Depths ranging from 1 to 7' bgs
  - 500 gallon UST found during excavation
- Chemical treatment of excavated soil
  - Sodium hydroxide solution
  - Chemical surfactant and sodium persulfate solution
- PID used prior to and following chemical treatment

- Site restoration
  - Backfilled with treated soils, following receipt of lab results
  - Impervious cover replaced
- Groundwater monitoring event in May 2023
  - Decreasing groundwater COCs with distance from source
  - Groundwater delineated to target levels protective of receptors
- Final closure letter issued July 2023
