Post-Disaster Safety
Assessment Program
(SAP)

Evaluator Training

Student Manual

Safety Assessment Program Evaluator Student Manual

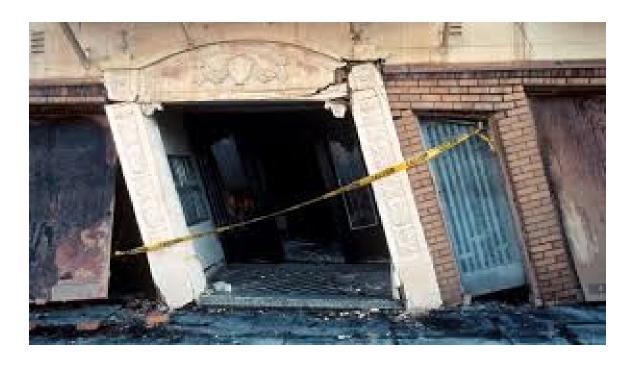
Figure 2-11 – Soft story racking damage.

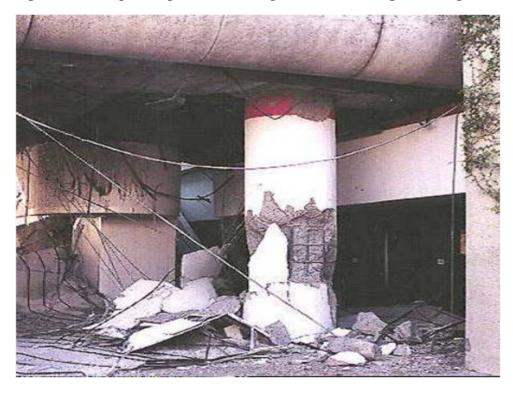
Figure 2-19 – Damaged column at department store, 1994 Northridge Earthquake

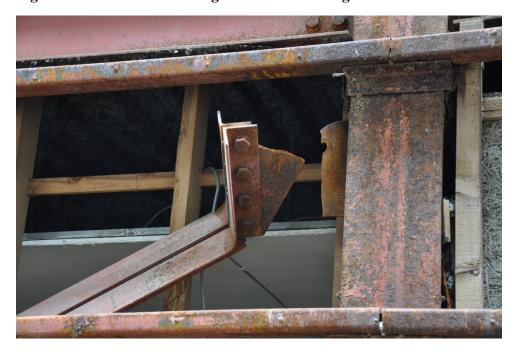
Figure 2-21 – Failure of steel gusset plate.

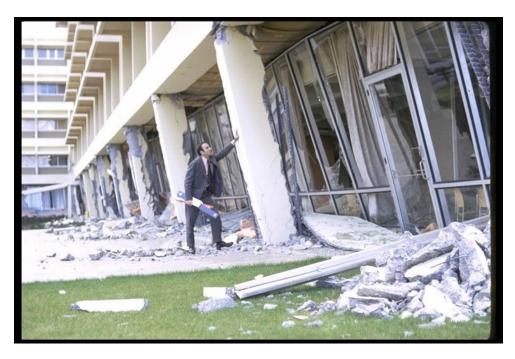
Figure 2-22 – Failure of concrete moment frame.

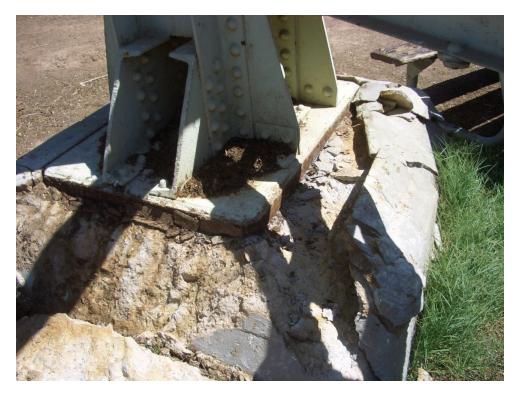
Figure 2-25 – Damage to water tower concrete footing

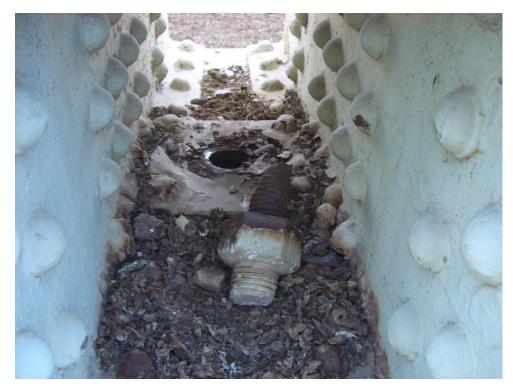
Figure 2-26 – Snapped bolt at footing of water tower

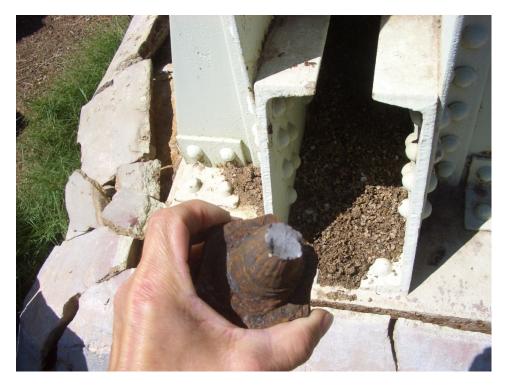
$Figure\ 2\text{--}27-Drawn\ and\ snapped\ connector\ at\ footing\ of\ water\ tower,\ also\ note\ footing\ damage$

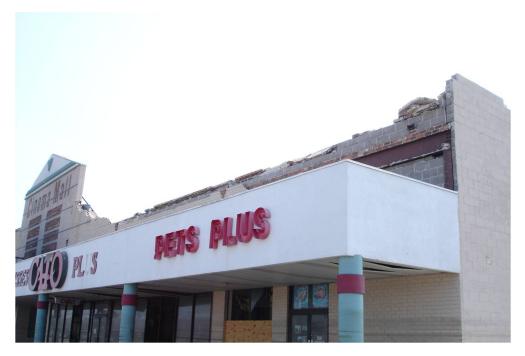
Figure 3-2 – Parapet blown off, 2005 Hurricane Katrina

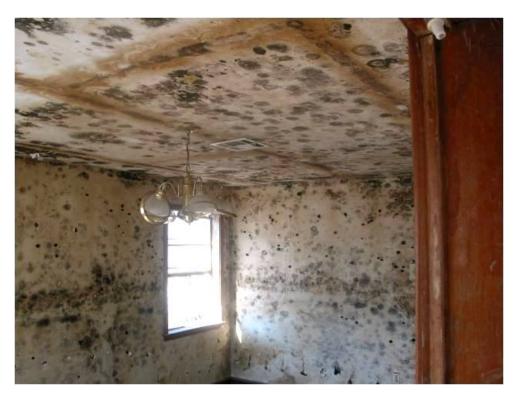
Figure 3-10 – Mold growth, 2005 Hurricane Katrina

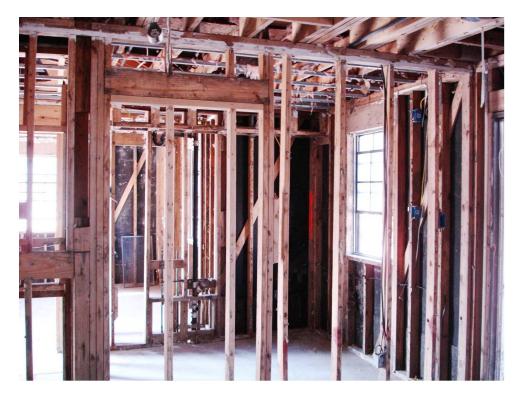
Figure 3-11 shows what needs to be done as part of the repairs: the wallboard, insulation, and electrical must be stripped out, and even the studs may have to be treated with bleach or fungicide before rebuilding can start.

Figure 3-11 – Wood frame structure under cleanup, 2005 Hurricane Katrina

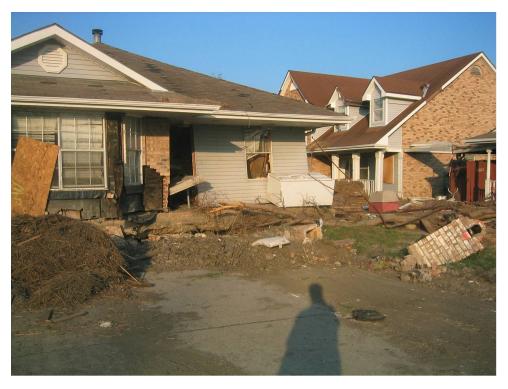
Figure 3-15 – Floated home with post-tensioned concrete slab, 2005 Hurricane Katrina

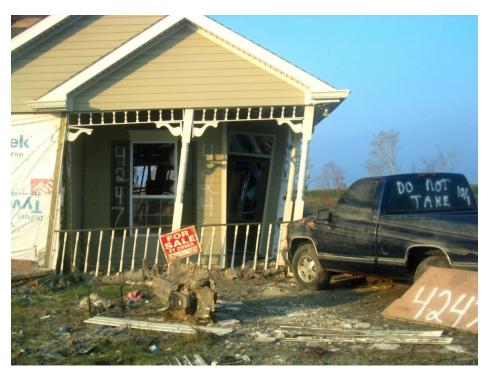
Figure 3-21 shows a wood frame building that suffered racking damage during Hurricane Katrina.

Figure 3-21 – Racking damage to wood frame building, 2005 Hurricane Katrina

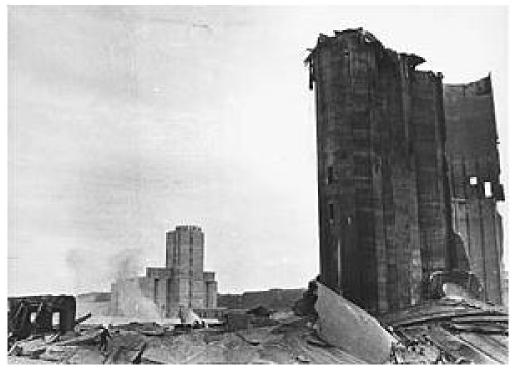
Figure 3-25 shows a granary built of reinforced concrete that was blown apart in a dust explosion. Flammable dusts present an explosion hazard when in the right fuel-to-air ratio and in the presence of a spark or flame. Flammable dusts can include flour, paper or wood dust, or even the dusts of certain metals.

Figure 3-25 – Explosion – damaged granary

Granary explosions are historically rather common, and are the chief reason why granaries are built of concrete or masonry instead of wood.

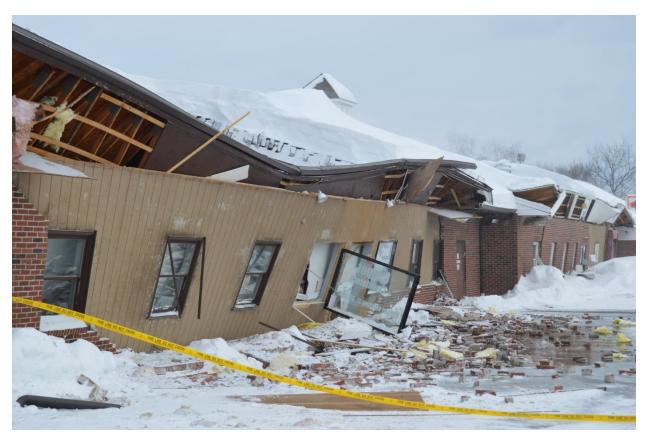
Figure 3-36 - Snow-caused roof and structure collapse in Massachusetts.

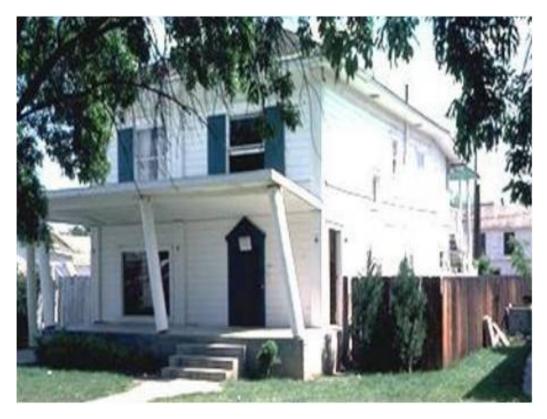
Figure 6-19 - House with cripple wall damage, 1983 Coalinga Earthquake

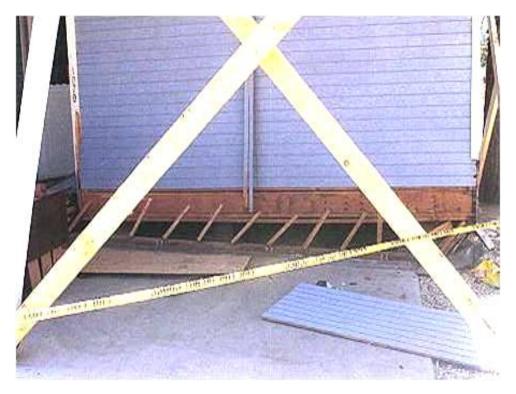
Figure 6-20 – House with cripple wall failure, 1992 Big Bear Earthquake

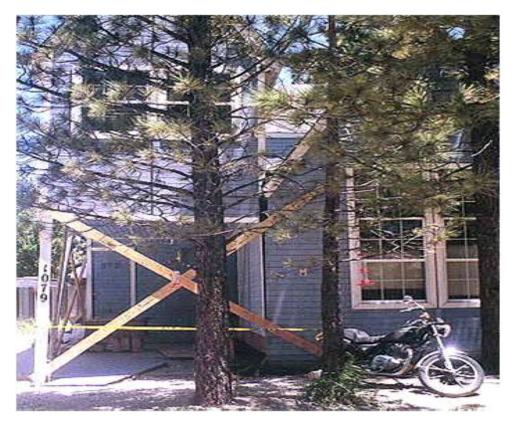
Figure 6-22 – Collapsed house with failing upper room, 1992 Big Bear Earthquake
